**CRS No. A-00001**

Name: Dwelling, 299 Bowers Beach Road

CULTURAL RESOURCE SURVEY  
PROPERTY IDENTIFICATION FORM

1. HISTORIC NAME/FUNCTION: Dwelling, 299 Bowers Beach Road
2. ADDRESS/LOCATION: 299 Bowers Beach Road
3. TOWN/NEAREST TOWN: Little Heaven vicinity? ☒
4. MAIN TYPE OF RESOURCE:      building ☒      structure ☐      site ☐      object ☐  
   landscape ☐      district ☐
5. MAIN FUNCTION OF PROPERTY: Residential
6. PROJECT TITLE/ REASON FOR SURVEY (if applicable):  
SR1, Little Heaven Grade Separated Intersection Improvements

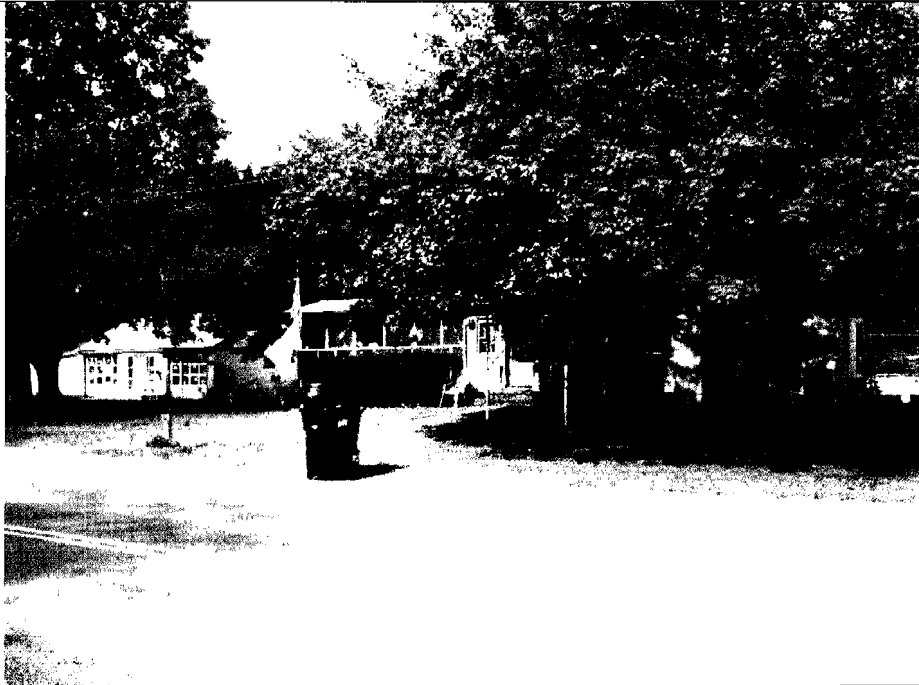
A-00001. Photograph 1: Overview of 299 Bowers Beach Road (dwelling and garage) looking west. The dwelling was moved to this location in 1948.

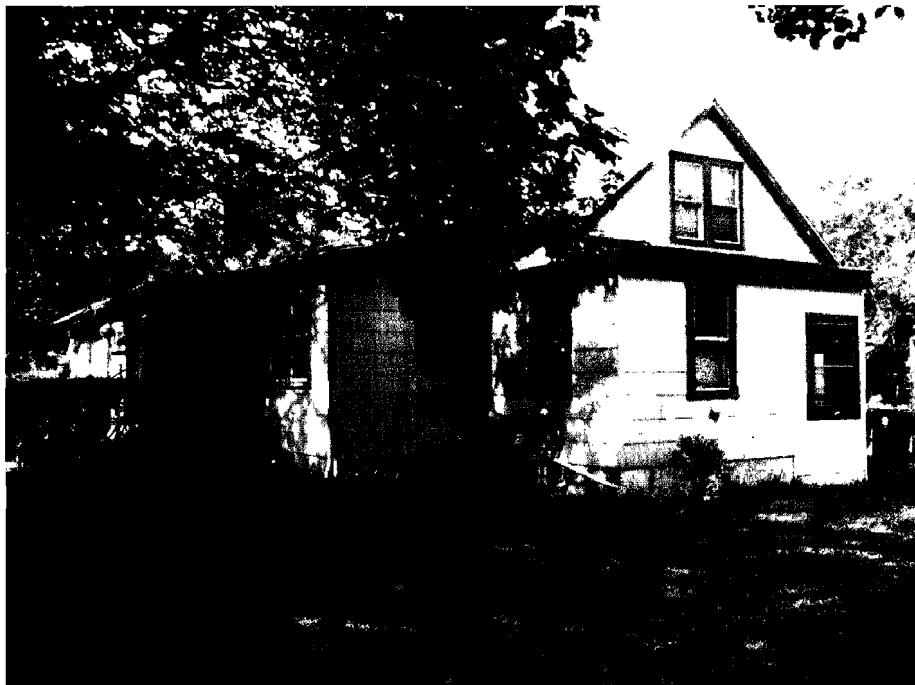
A-00001. Photograph 2: Dwelling, south and east elevations, looking west. The dwelling is clad in asbestos shingles and is lit by one-over-one light, double-hung sash, wood windows.

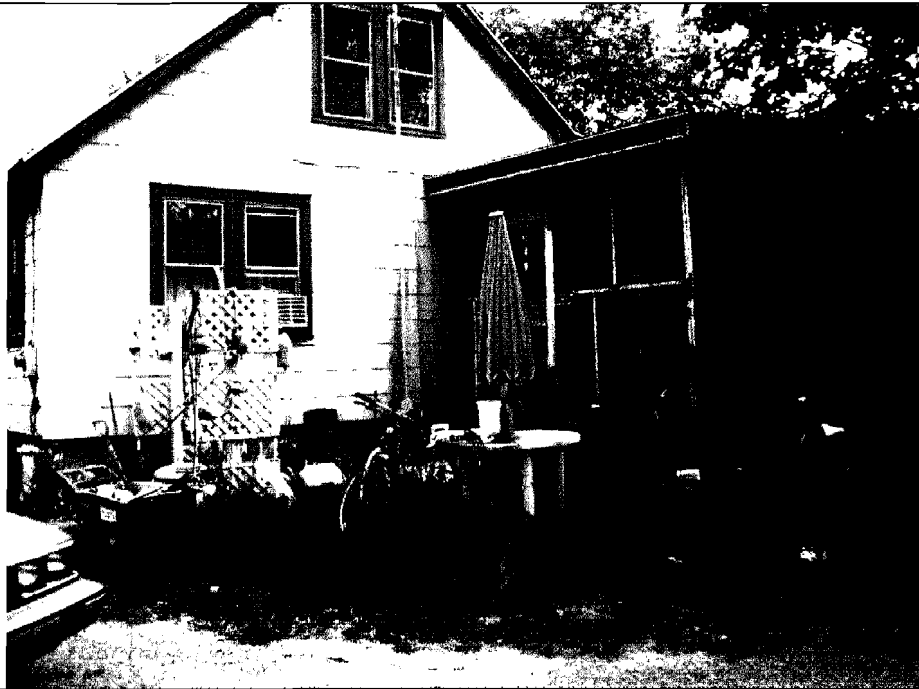
A-00001. Photograph 3: Dwelling, west elevation, looking east. Note the screened-in porch to right.

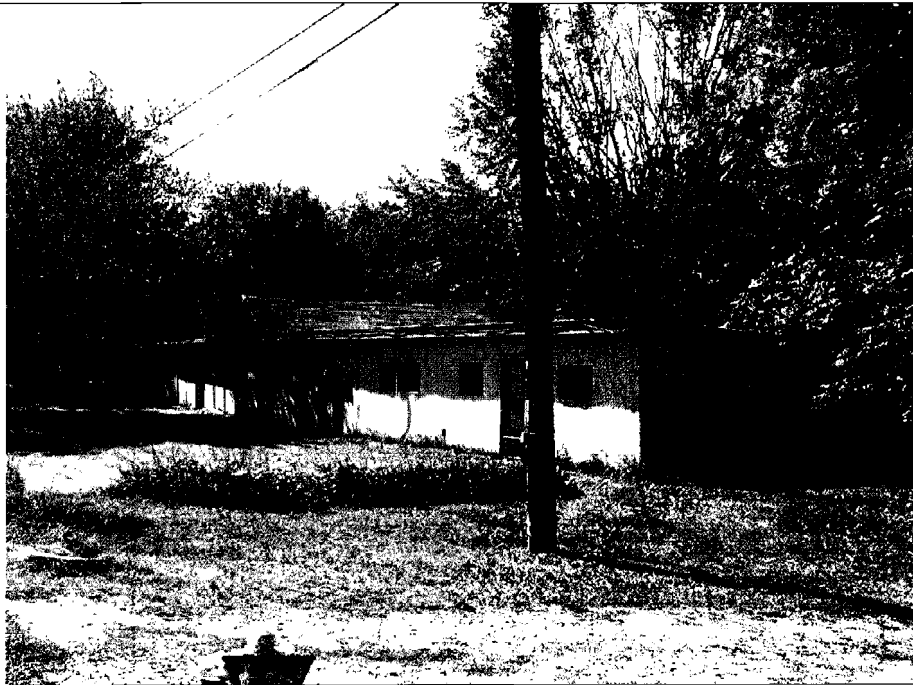
A-00001. Photograph 5: Chicken house 1, south and east elevations, looking west. Note the front-gable center section of the building, which appears to predate the east and west wings. This chicken house was later converted into apartments.

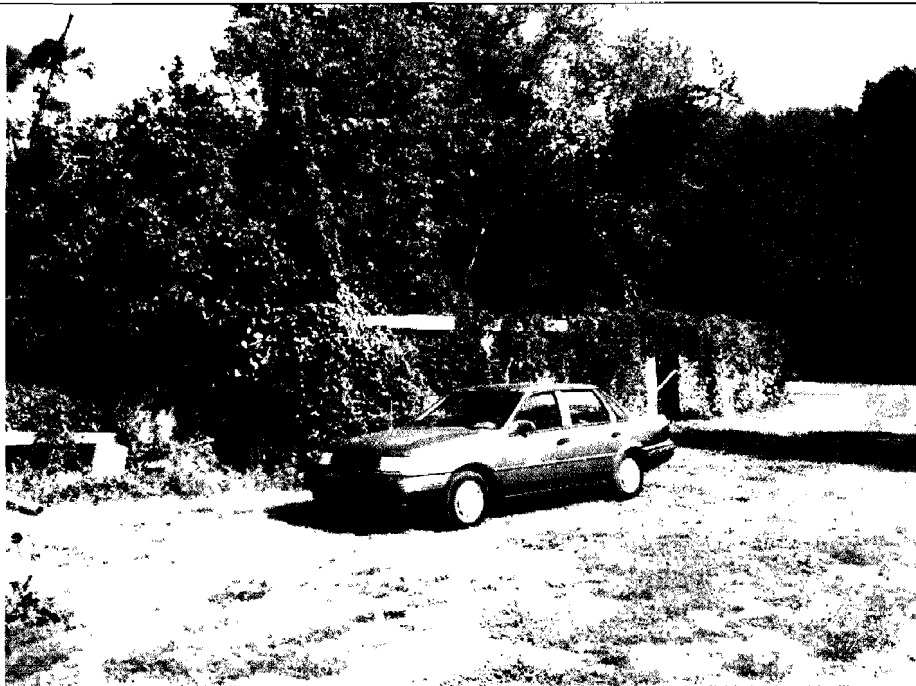
A-00001. Photograph 7: Chicken house 3, south elevation, looking northeast. Ivy and other overgrown vegetation obscure this chicken house.
